NBS TECHNICAL NOTE 569

Hurricane Camille- August 1969

A Survey of Structural Damage
Along the Mississippi Gulf Coast

One week after Hurricane Camille devastated the Mississippi-Louisiana Gulf Coast with 125 mph winds and 20-ft tides on August 17, 1969, a four-man NBS team investigated the damage to buildings and other structures. This report presents photographic survey data from this investigation along with additional data on wind speeds and storm surge. Based on these data, suggestions are made pertaining to the improvement of building design and construction practices.

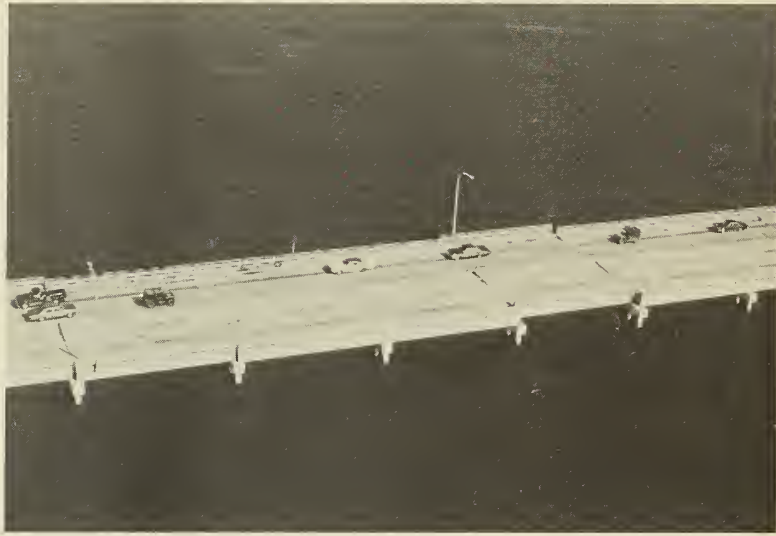
Figure 6. Biloxi Bay Bridge, Biloxi, Mississippi.

As indicated in figure 3, maximum wind speeds and surge heights in the Biloxi area were approximately 105 mph and 18 ft respectively. Precast concrete deck slabs of the Biloxi Bay Bridge (fig. 6) were moved longitudinally on their pile bents by surge-borne waves. Some slabs were displaced as much as 3 to 4 ft and considerable debris was lodged in the bridge railing. The ground floor of the Buena Vista Motel (fig. 7) was completely gutted by waves and extensive wind damage to the roofing was observed. Note the proximity of the structure to the water.

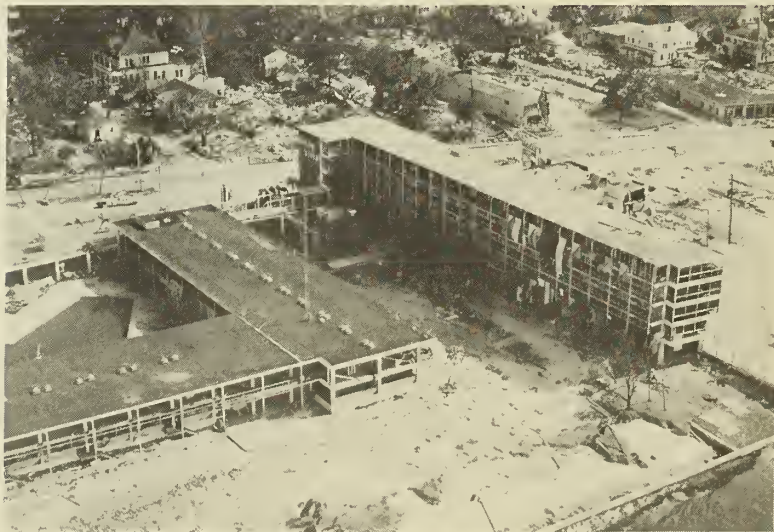
Figure 8. Coastal area, Biloxi, Mississippi.

Structures on slightly higher ground fared much better even though their ground floors and basements were flooded (fig. 8). Generally, surge damage was limited to those areas within two blocks of the beach.

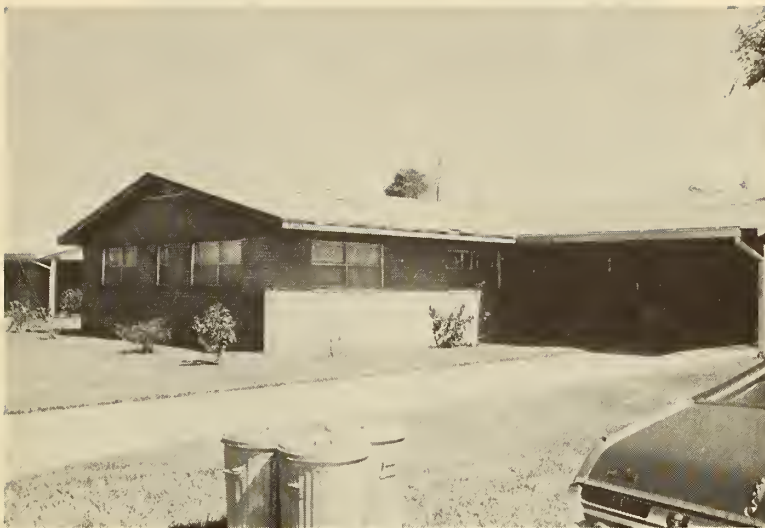
Figure 10. Single-family residence, Keesler Air Force Base.

Keesler Air Force Base - Damage to buildings was limited to loss of cladding and roofing with some flooding occurring in housing developments located along the back bay. The chapel shown in figure 9 suffered the most serious damage with the loss of copper roofing and subsequent water damage to the interior furnishings. Single-family dwellings with wind-resistant shingles exhibited very little damage (fig. 10).

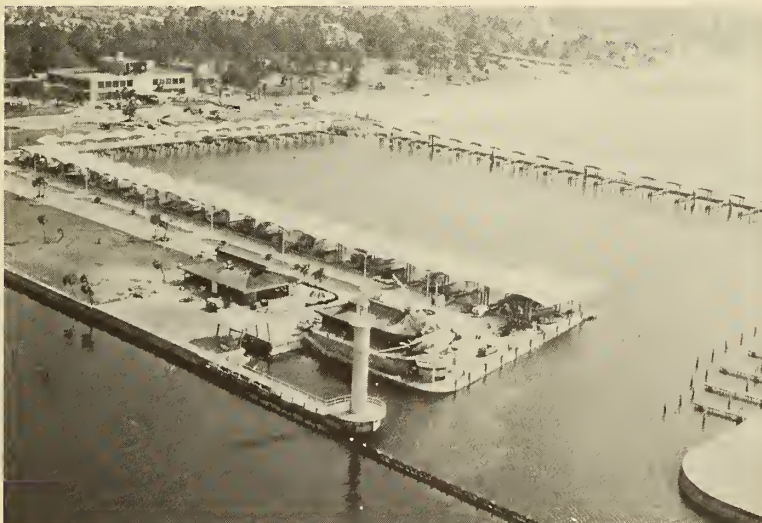
Figure 11. Broadwater Beach Marina between Biloxi and Gulfport, Mississippi.

Broadwater Beach Marina - This marina (fig. 11) near Biloxi consists of reinforced concrete columns and double-T roof members over the boat slips. Although some of the roof members were damaged (fig. 12), the overall performance of the structure was very good considering that it was completely inundated by the storm surge. Surge height in this area (approximately half way between Biloxi and Gulfport) was about 20 ft.

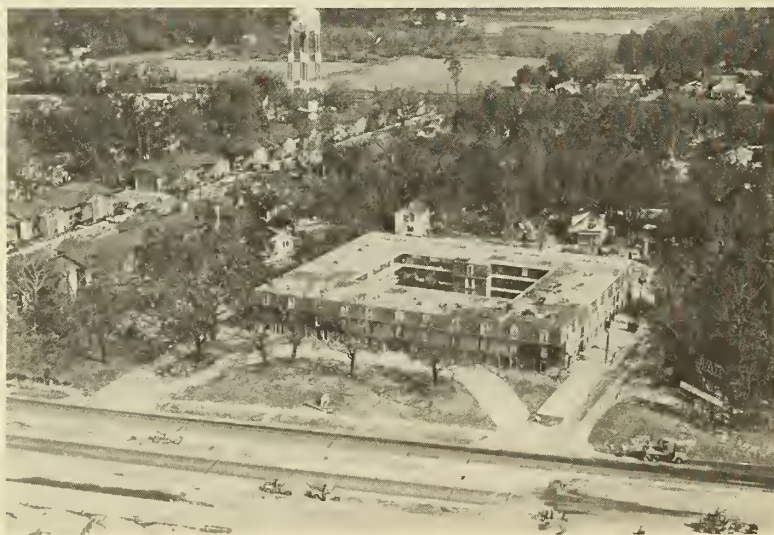
Figure 13. Residential area between Biloxi and Gulfport, Mississippi.

The building shown in figure 13 suffered heavy damage due to wave action and wind. Note the damage to roofing near the windward corner of the building. This type of damage is typical of flat-roofed structures investigated by the team. Although the seawall generally suffered light damage, considerable erosion was observed behind the wall and under the adjacent pavement slabs of U.S. 90 as indicated in figure 14.

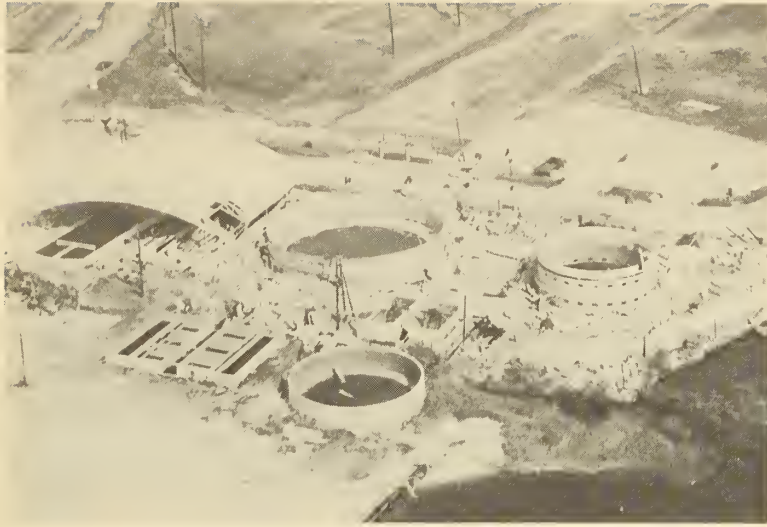
Figure 16. Marine Life Aquarium, Gulfport.

20-ft storm surge. One group of buildings in this area comprised the Marine Life Aquarium (fig. 16). The large steel-arched building at the left provided shelter for a display tank and a concrete seating area. Detailed description of the damage to these structures has been reported by another survey team [10].

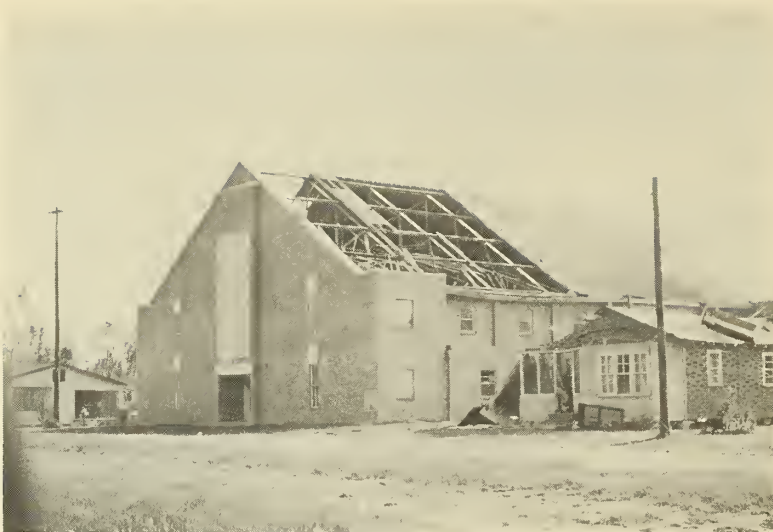
Figure 18. Church located in northern part of Gulfport.

The effect of building geometry on local wind pressures is demonstrated by the church in figure 18. This structure is located approximately 3 miles inland and probably experienced peak gusts when the wind was blowing from left to right. Strong vortex flows can develop along the eaves of the gable end, resulting in extremely high suctions. Failure of this roof structure is quite similar to that depicted in figure 9.

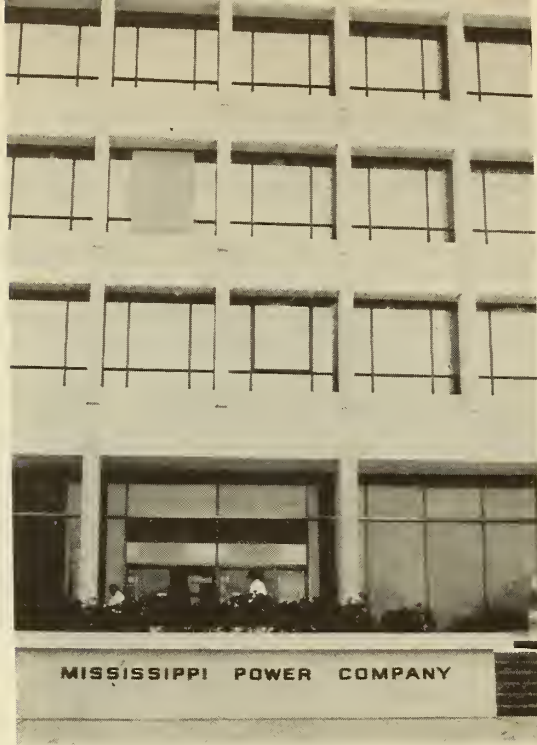
Figure 20. Close-up view of Mississippi Power Company building.

through seventh floors (fig. 20) [11]. The large first-floor windows were protected from flying or floating debris by a wire fabric screen which was erected just prior to the storm. The windows consist of one-inch thick panels of insulating reflective glass set in bronze anodized aluminum framing with neoprene gaskets. The neoprene gaskets provide a resilient mounting for the glass and prevented metal-to-glass contact and minimized breakage. After the storm, it was reported that, out of more than 500 windows, a total of 13 lights had to be replaced [11].

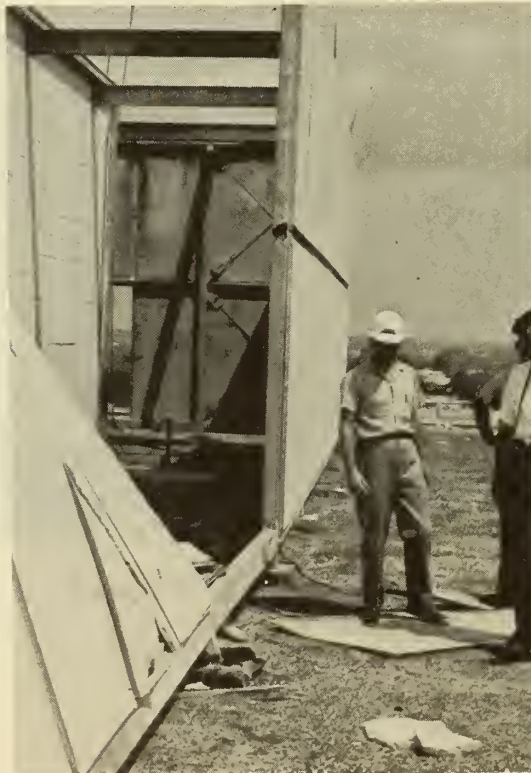
Figure 21. Enclosure structure on roof of Mississippi Power Company building, Gulfport, Mississippi.

In addition to the window damage, some minor damage occurred to one side of the roof enclosure surrounding the air-conditioning cooling tower (fig. 21). The structure for the enclosure consisted of rectangular structural steel tubing and 2-in thick concrete panels which were reinforced with expanded metal lath.

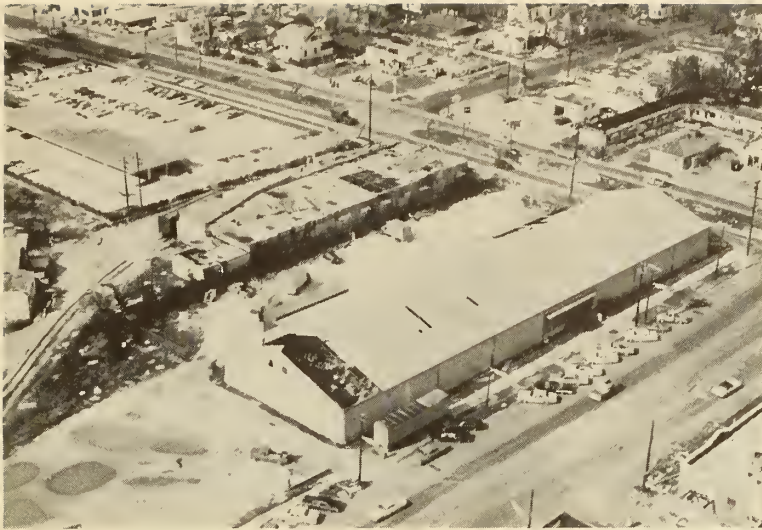
Figure 22. Area directly north of Mississippi Power Company building.

Figures 22 through 24 indicate the general level of damage in the area surrounding the Mississippi Power Company. The prefabricated metal building in figure 22 again points up the importance of local wind effects when designing roof elements. The random distribution of damage shown in figure 23 is typical of the entire area covered by the survey. Failures of roofing are usually progressive as is indicated in figure 24. Gravel from this built-up roof contributed considerably to the flying debris.

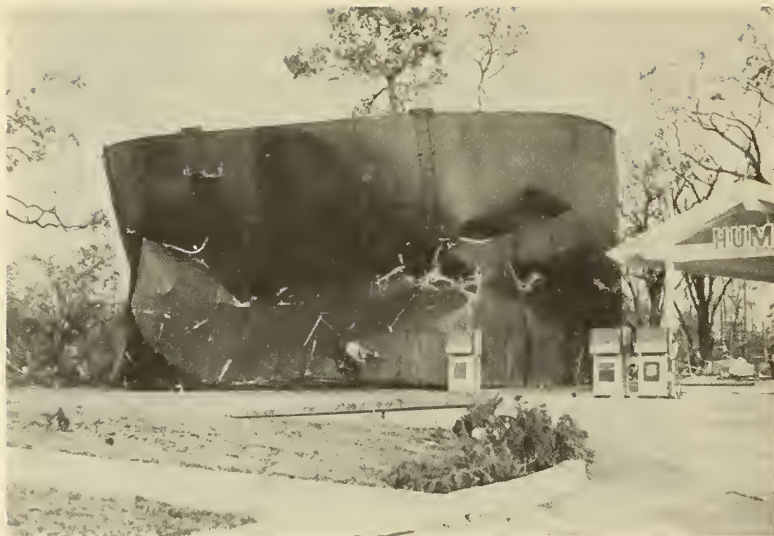
Figure 27. Metal roofing damage, Gulfport, Mississippi.

An old wood-frame house (fig. 27) escaped major damage except for its metal roof covering.

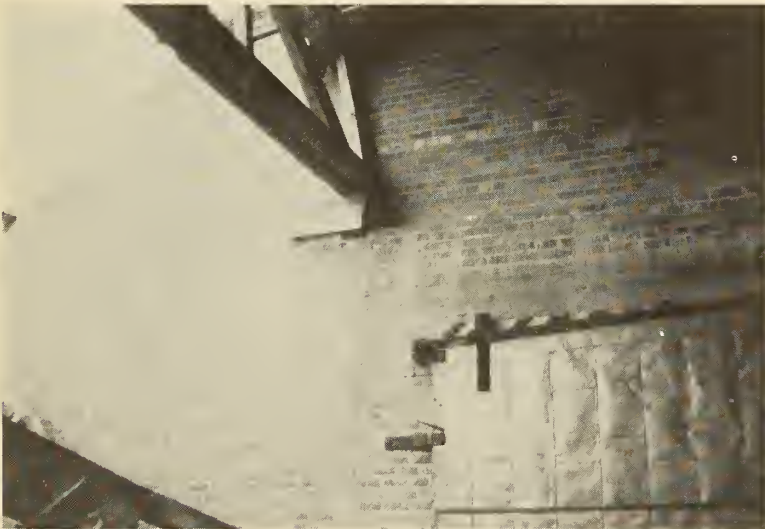
Figure 32. Reinforced concrete and masonry warehouse, U.S. Naval C. B. Center, Gulfport.

Comparatively minor damage was suffered by three reinforced concrete-masonry warehouses (fig. 32) which were built during or since 1950. These warehouses were located near the older wood-frame warehouses (see upper left of fig. 29). As shown in figure 33, these structures lost some 2-ft wide by 8-ft long precast concrete roof panels along the perimeter of the roof. It was observed that all roof panels were securely anchored at interior points by steel clips but no anchorage was provided for the perimeter panels, the location where peak uplift usually occurs. Prior to the passage of Hurricane Camille, it was reported to the NBS survey team that hundreds of civilian dependents left their homes to take refuge in these concrete-masonry warehouses.

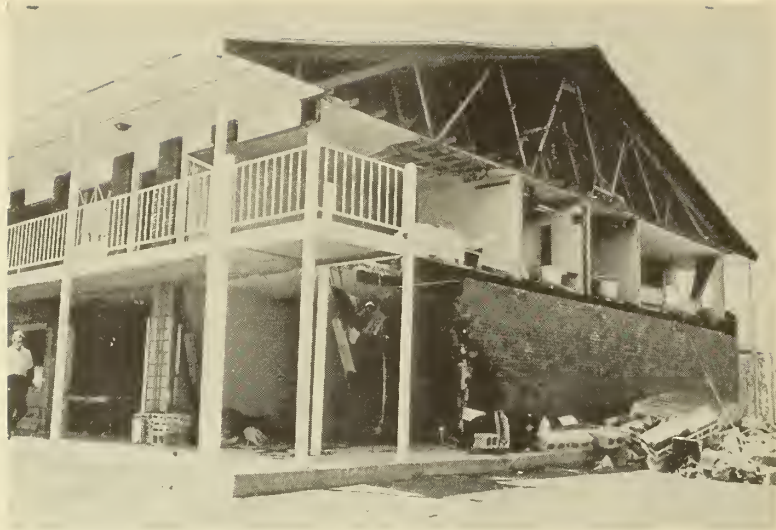
the restaurant area (fig. 49) experienced extensive water damage. On the east end of the main building, the top-story portion of a masonry wall had collapsed (fig. 50). An inspection of this brick and block wall indicated it contained some vertical reinforcement; however, the block cells containing this reinforcement did not contain any grout or concrete (fig. 51).

Figure 50. Damaged masonry wall on east end of main building, Ramada Inn.

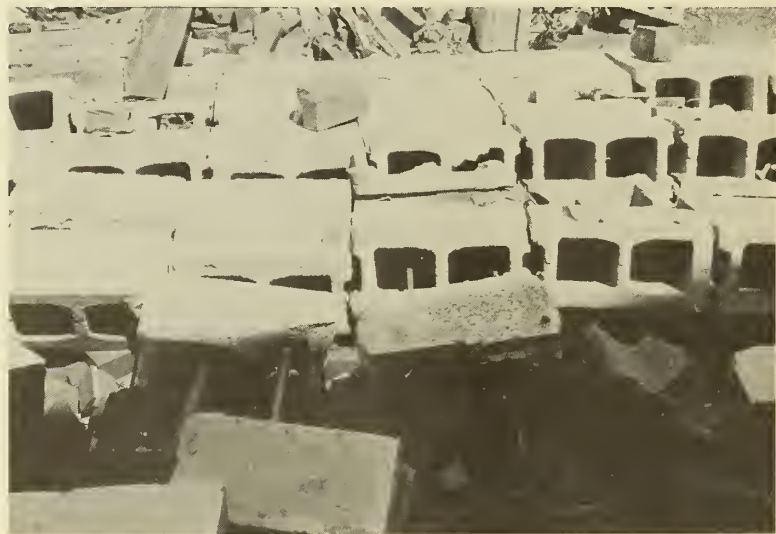
Figure 51. Damaged masonry wall, Ramada Inn; block cells containing vertical reinforcement were not grouted.

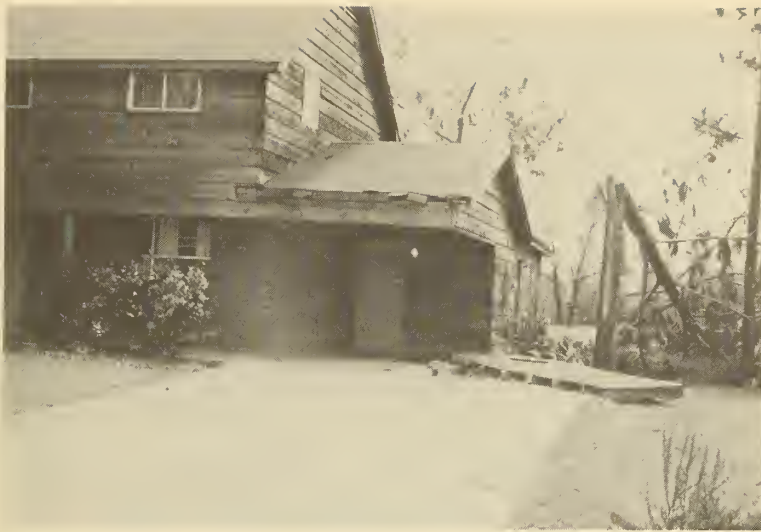
Figure 67. Single-family residence, Waveland, Mississippi.

A residence and a bank building, which were struck by waves, are illustrated in figures 67 and 68. The residential building lost most of its exterior and interior wall coverings but the good anchorage of the wood-stud walls to the concrete slab foundation and to the timber roof prevented total destruction. As shown in figure 68, the bank building was completely destroyed except for the reinforced concrete vault and building frame.

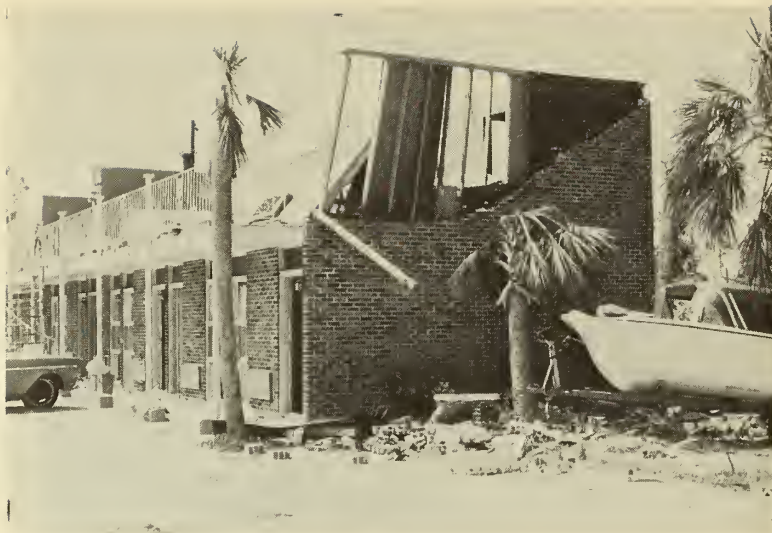
Figure 71. Motel, U.S. Highway 90 near Waveland, Mississippi.

Across the highway from the small motel is a larger two-story motel, which has a flat concrete roof overhanging the second-story balcony (fig. 71). In this building the roof structure was apparently heavy enough and anchored satisfactorily to resist the uplift forces. The only damage observed was to the built-up roofing and underlying insulation.

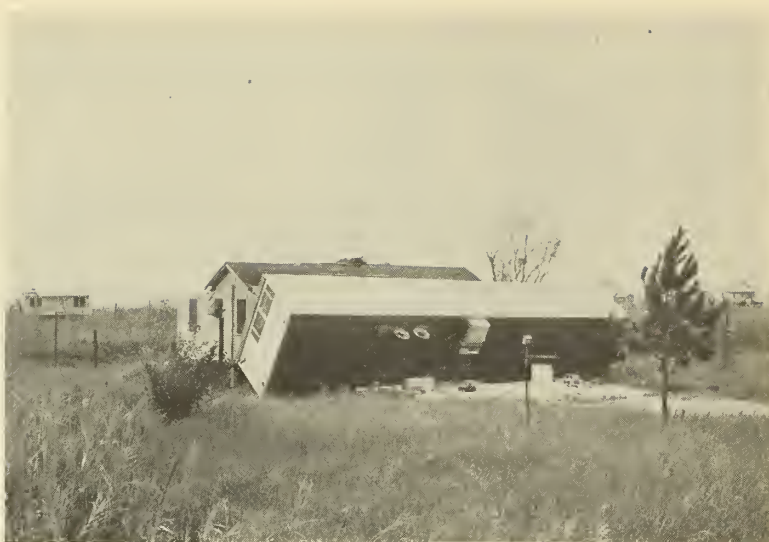
Figure 72. Damaged mobile home, U.S. Highway 90 near Pearlington, Mississippi.

One of the many mobile homes which were overturned is shown in figure 72. This particular mobile home was located in Louisiana on U.S. Route 90 just west of Pearlington, Mississippi.

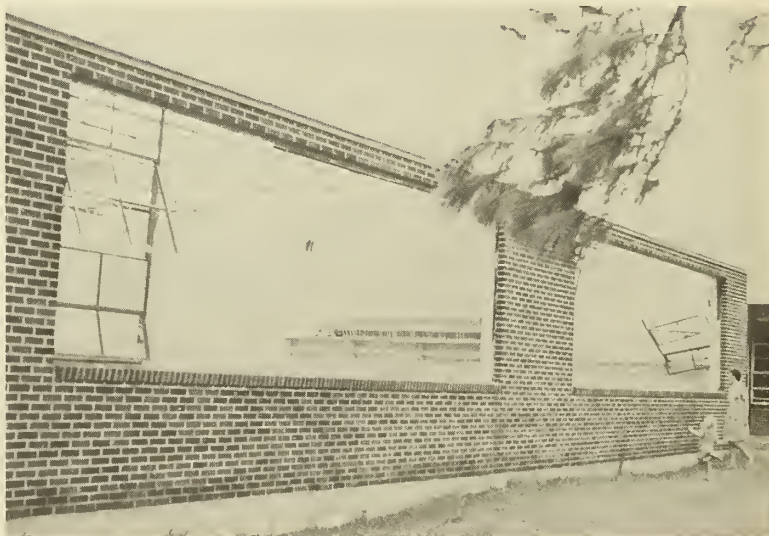
Figure 73. North Central High School between Waveland and Poplarville, Mississippi.

North Central High School is located on County Road 603 about 15 miles north of Waveland, Mississippi. The main school buildings are constructed with brick and block walls and a steel joist roof system. As shown in figure 73, the roof covering and insulation were stripped from the buildings and the windows were badly damaged. This exterior damage also resulted in extensive rain damage to the interior and contents of the buildings.
